Energy Audit Report of

ARYA Institute of Engineering and
Technology, Kukas,
JAIPUR (Rajasthan)

3E Solutions
Electrical • Energy Audit • Environment

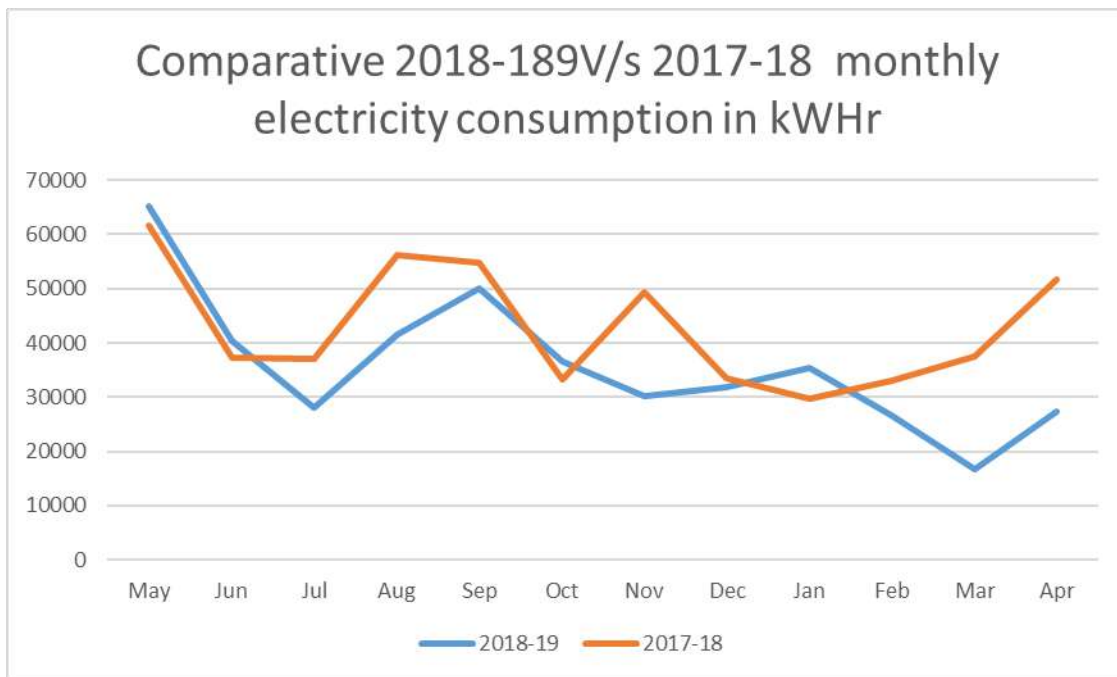
Total Grid Electricity Consumption is approx 0.3759613 Lacs of electricity Units per month. Comparative consumption pattern of electricity for the years 2017-18 and 2018-19 is shown below:

Highest Electricity is consumed in the month of April & May, however in the month of April and May 2019, the billed units came down due to commissioning of approx. 280kWp of solar source of electricity. This can be better visualized with the following chart where as April and May total consumption have also been projected based on 10% increase in summer demand in loads.

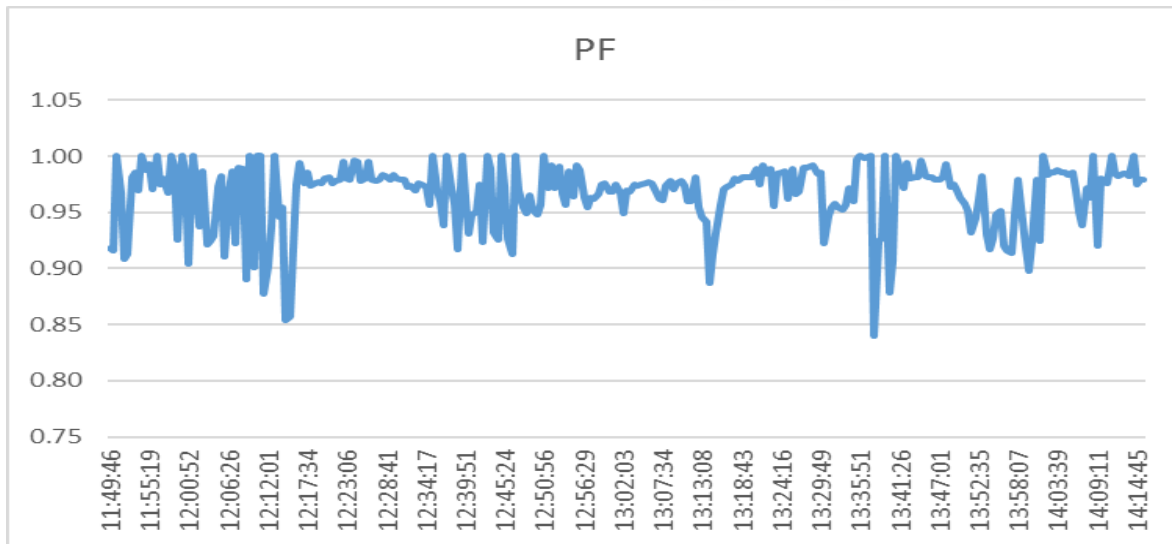
The power factor varies from 0.84 to 1.0 and average approx 0.98 which will improve after faulty capacitor removed from Auto to manual. PI replace as soon as possible.

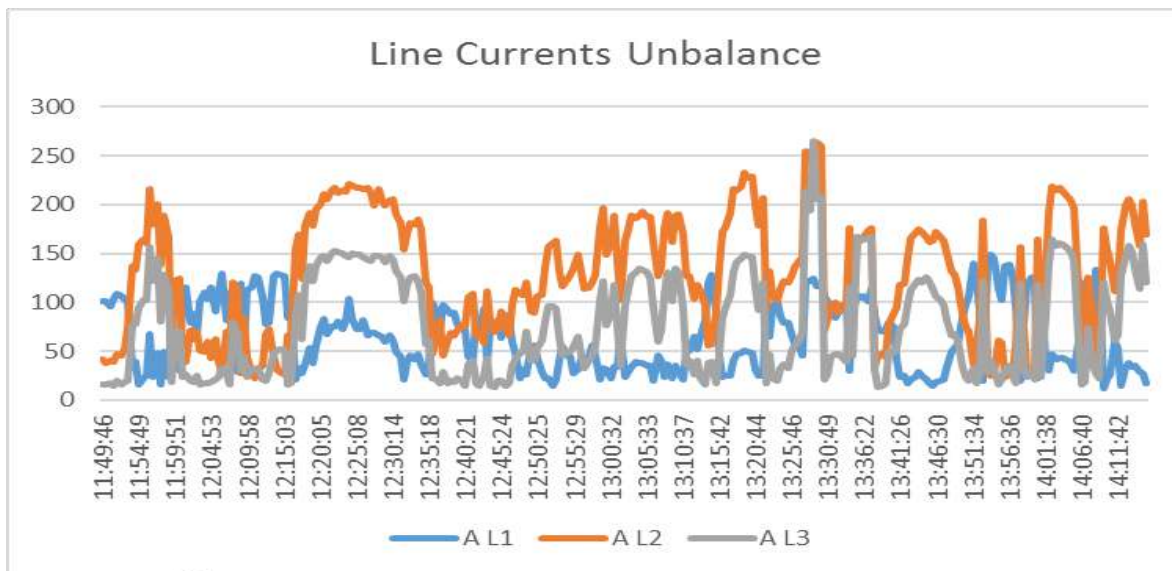
2.6.2 The Line currents L1 varied from 12 Amp to 149 amp with average 65 amp, L2 varied from 22 Amp to 263 Amp with average 128 Amp and L3 varied from 13 amp to 264 amp with average 77 amp. The variation is not acceptable practice in electrical engineering and efforts must be made to bring it down.

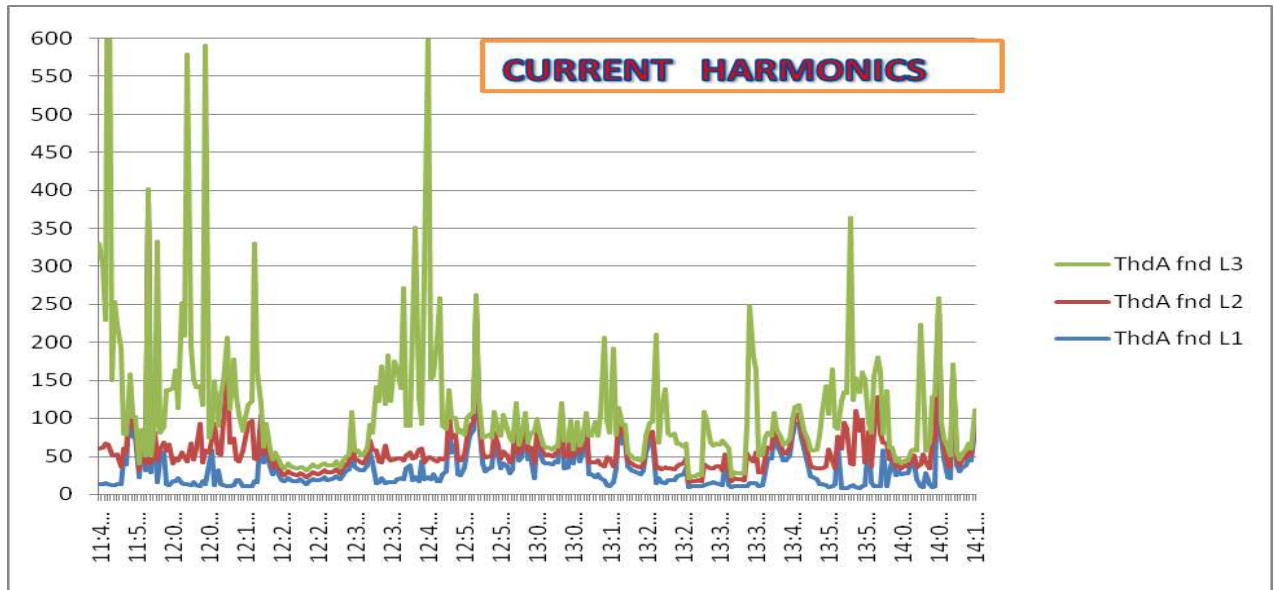
2.6.3 Current and Voltage Harmonics (THD) on 21.05.2019 from 11.50 am to 02.15 pm.

The harmonic distortion during the period was observed 13.6%, 22.8% and 155% however, the fundamental currents with this line were 99.1 Amp, 71.7 Amp and 10.6 Amp only. The unbalance is too high, however, the solar system was at peak during this time and supplied major current and current shown here was only current drawn from the grid at that point of time. The 155% harmonic component of L3 phase was sourced from third harmonic 10.6 Amp and fifth harmonic also 4.8 Amp which contribute roughly 100% and 50% of fundamental current.

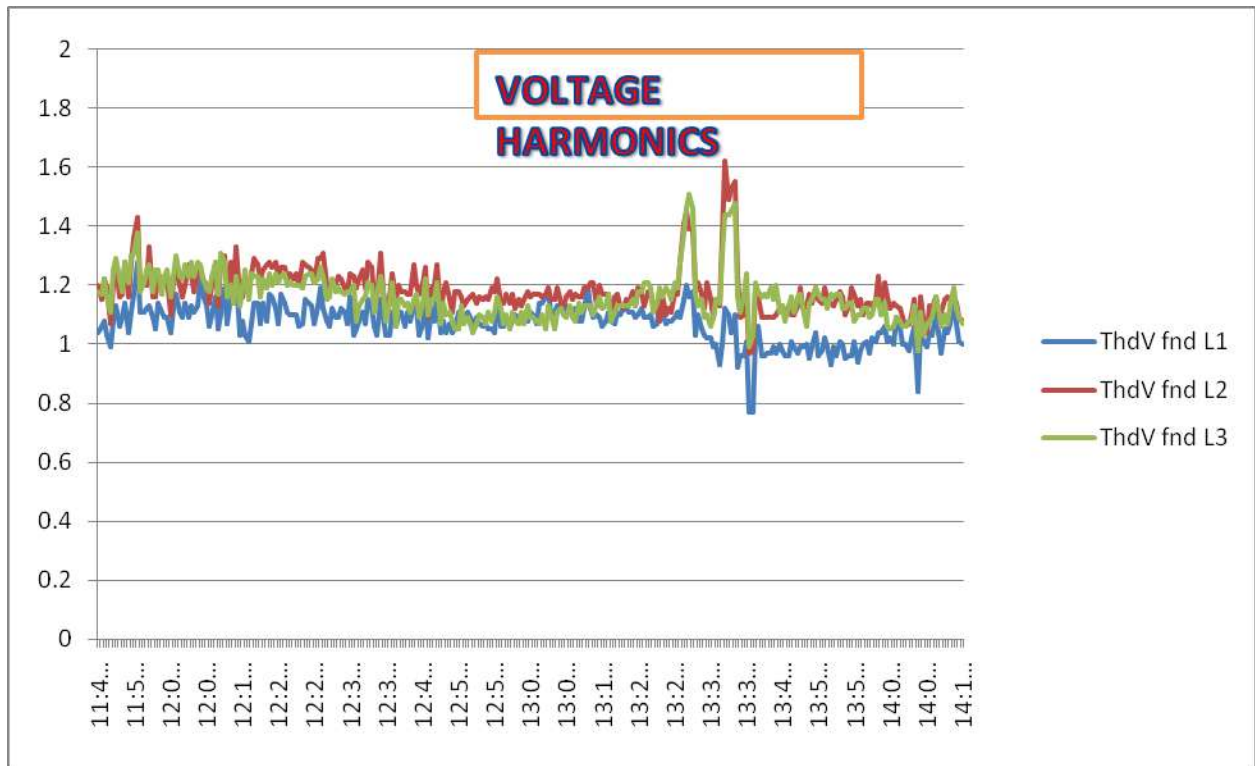
2.6.4 Voltage Harmonics are in order.

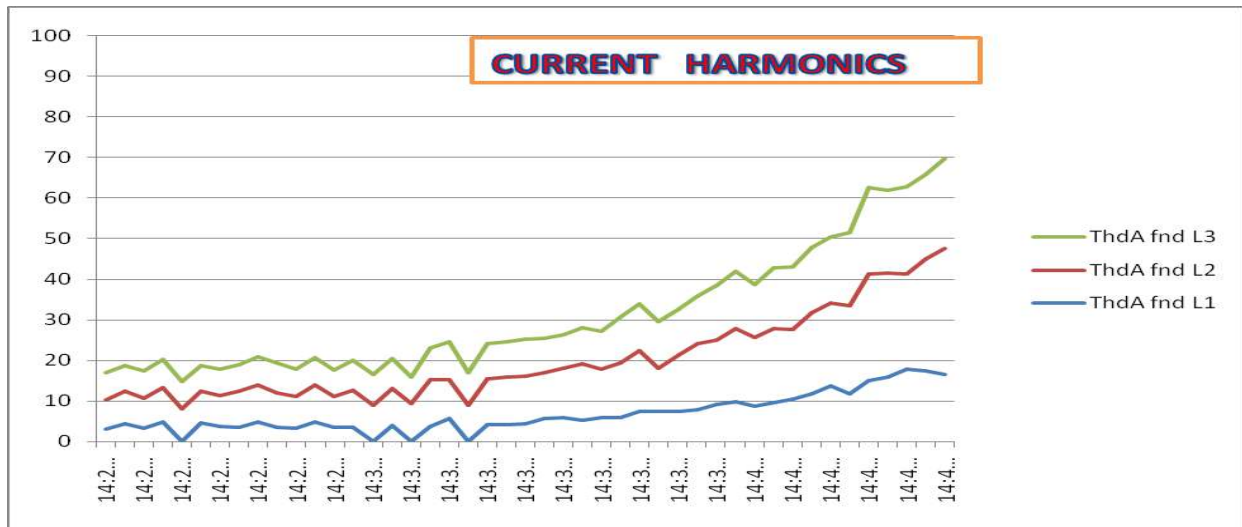
2.7.1 Current (THD) on 21.05.2019 from 2.23 pm to 02.45 pm of SOLAR panels connected to main LT bus bar. Graph shows that it is on higher side. Other electrical parameters were within range.

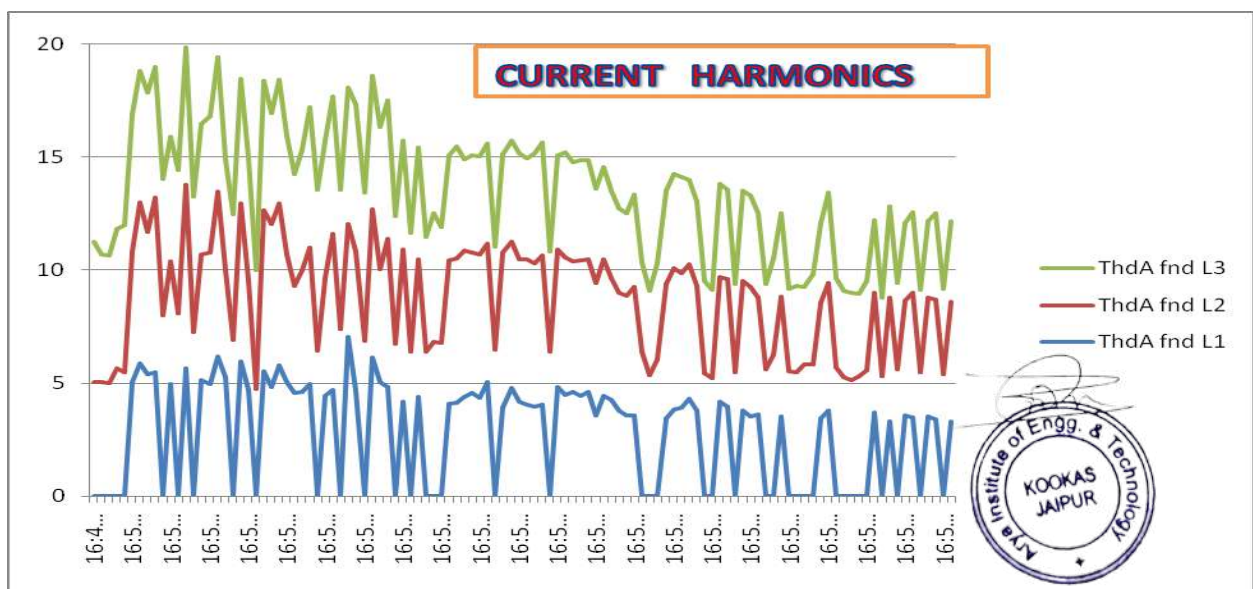
2.7.2 Current (THD) on 21.05.2019 from 04.49 pm to 04.59 pm of SOLAR panels connected to feeder near hostel. Graph shows that it is on higher side. Filters should be installed. Other electrical parameters were within range.

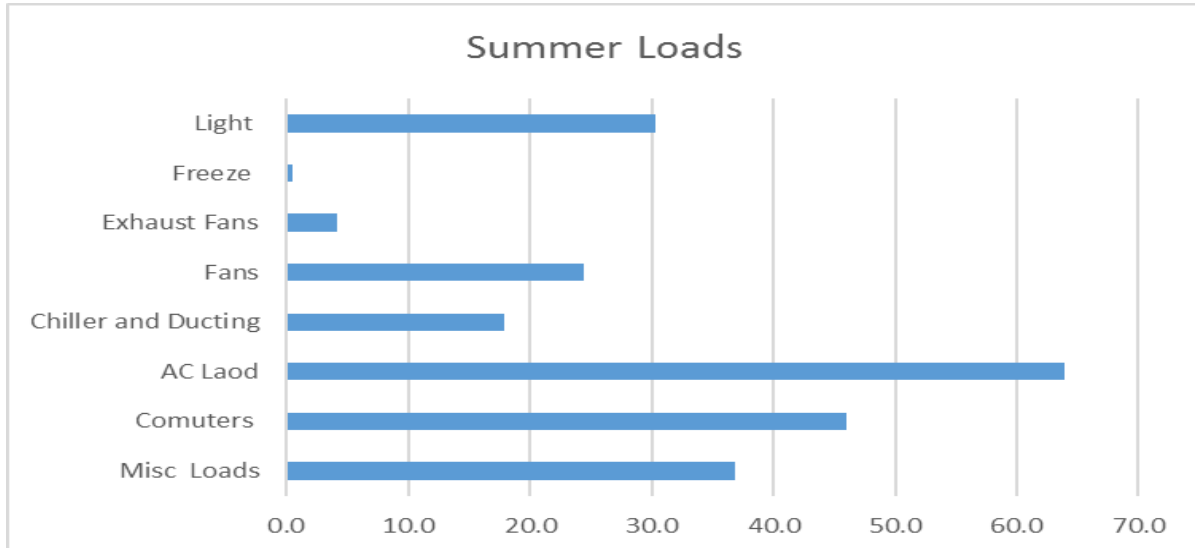
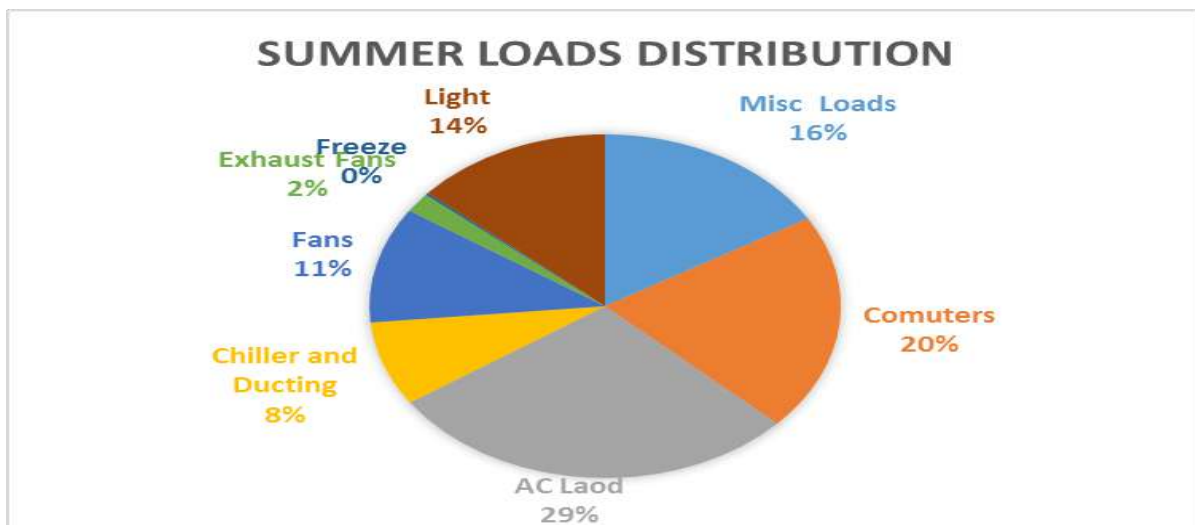
During Summer, the major loads are Air Conditioning and Computers. It was observed that mostly windows AC have been used for cooling and on top floor and hostel, the evaporative cooling has been used. We recommend to increase the evaporative cooling as much as possible whenever the cooling is required. The college is conscious at energy consumption and have formulated the practices of starting and stopping of coolers at predefined times. Further, the rooms of faculties and classrooms are occupied depending

Out of approx. 1200 Tube lights, almost 300 tube lights have been changed to LEDs and balance can be changed as early as possible. The UPS room and computers are major investments where only recommendation is distribution of phases for limiting unbalance in system. Fans runs the most be identified and replaced by BLDC technology fans. Motors which run more than 12 hours per day and approx. 5 years old can be changed to Energy efficiency motors.

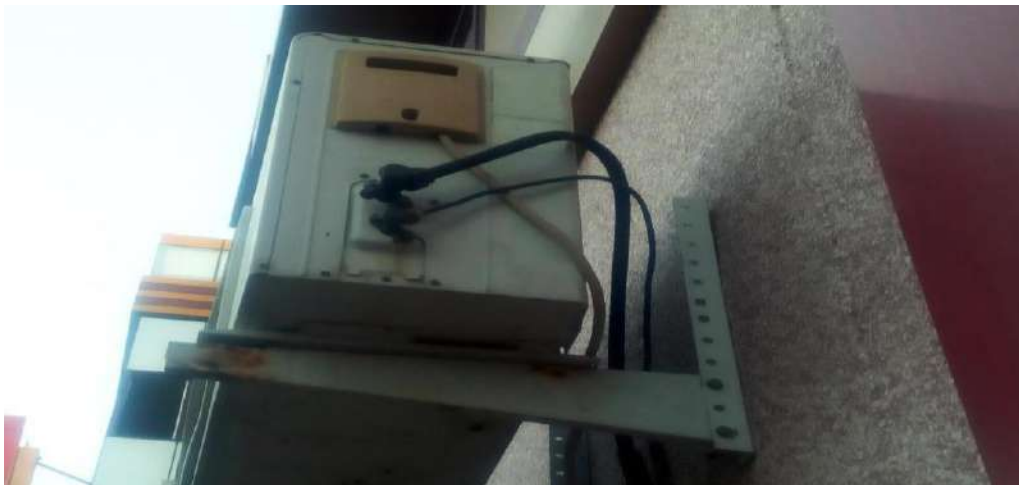
Set Point - 16° C. It should be 24°C. Placement of outdoor units is not proper.

- j. AC outdoor Units should be covered with shed and hot air exhaust path should be clear.
- k. AC – Copper tubes – Insulation needs to be replaced.
- l. Ensure that AC room temperature sensor should be in working condition and compressor should cut ON / OFF with it.

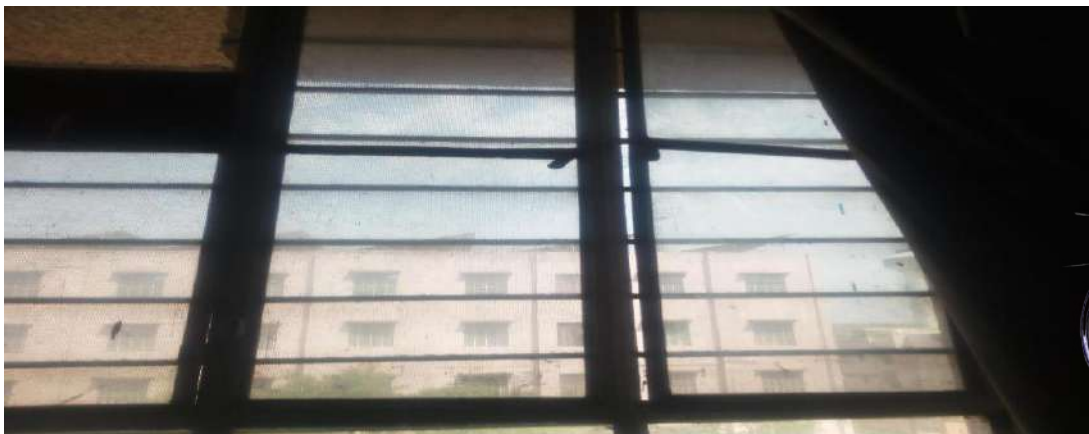
Outdoor units should be under shed. Tube insulation also missing.

2. Few Air conditioners checked for their performance. It is noticed that their TR is <75 % of the rated. This is due to either low quantity of refrigerant or their filter / condenser cleaning is not done on regular basis. Copper tubing insulation has damaged and needs to be reinsulated. Condenser units are also not covered with shed. Find the photo as attached.

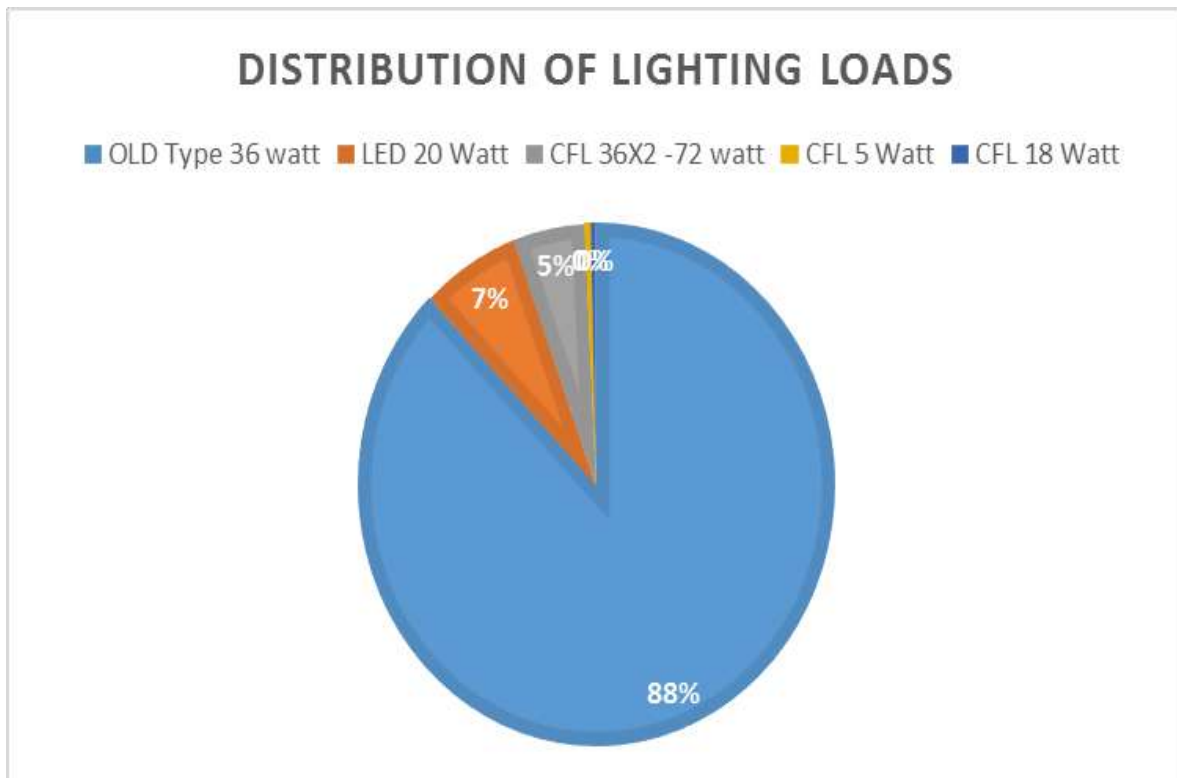
Approximately 88% of total monthly contribution of lighting loads in auditing month represents the Old type 36 watt + 12 watt Choke load consumption.

Under this representative case, if all such lights are changed to LED lights, lighting load is reduced from 12600 electrical units per month to 5850 units i.e. 6750 Units savings in terms of rupees Rs 54000/ per month in a approx. investment of Rs 2.50 lacs only capable of recouping investment in less than 5 months.

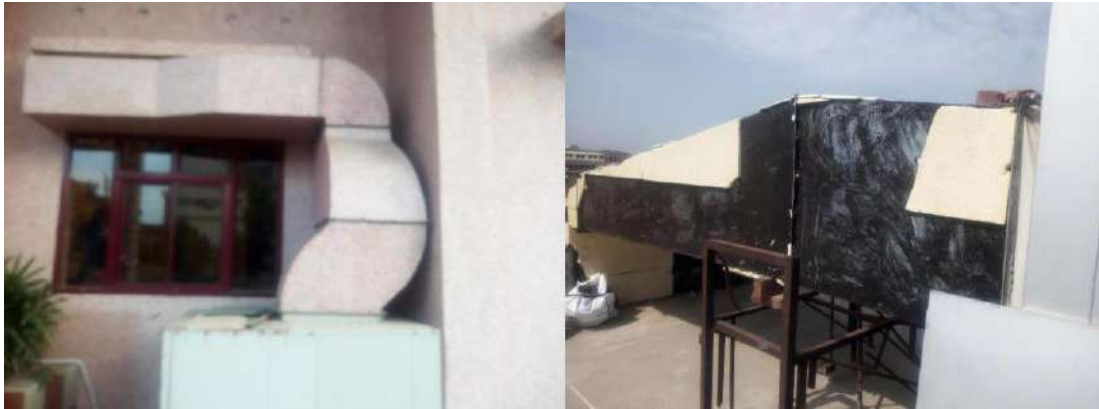
Outside Ducts can be insulated.

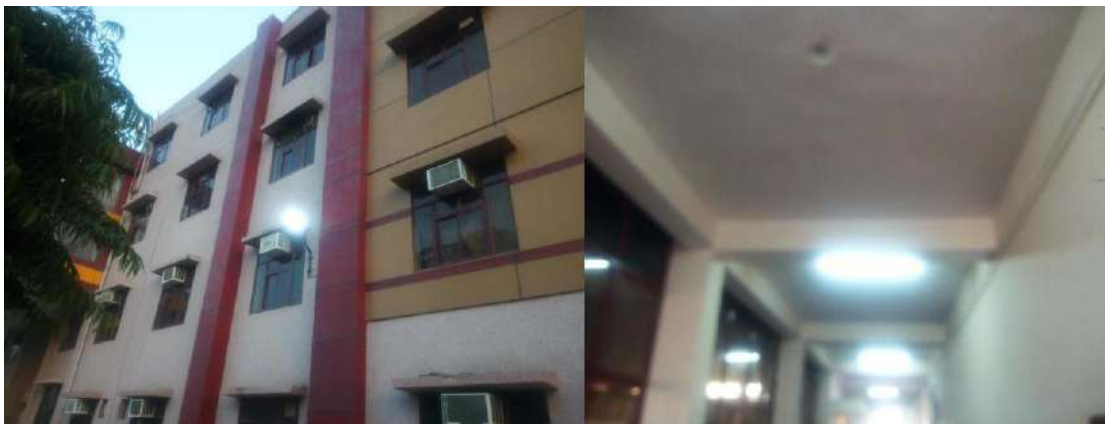
Lights found ON in day time in the morning.

- f. Lights, air conditioners and fans, area where no work is going on, should be put OFF. Occupancy Sensors and manual segregation for peak hours, off peak day hours.
Setting of AC should be kept around 25 plus / minus 2 degree centigrade.

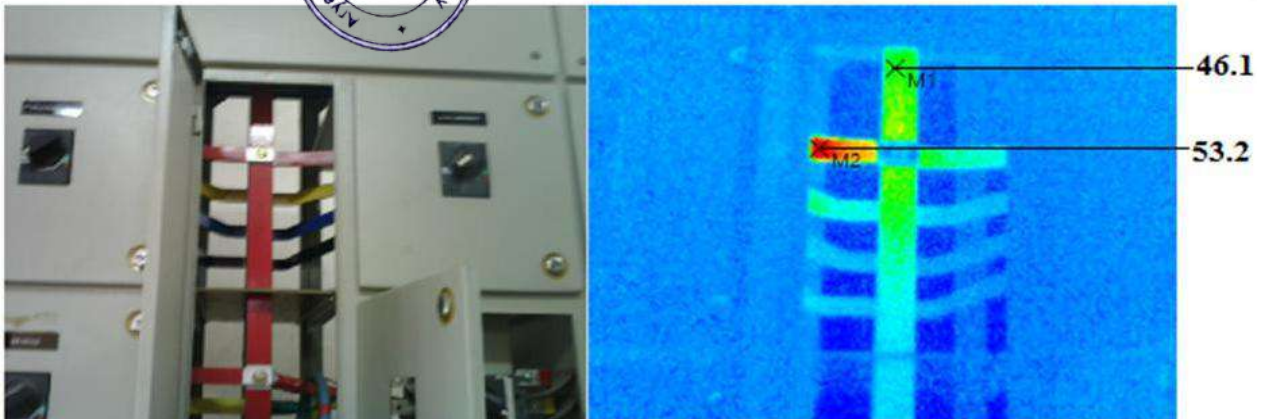
Location	Temperature	Remarks
Main Panel Bus Bar - AEIT Basement	53.2°C	
Main Panel Bus Bar Front Top Left	47.6°C	Healthy
Main Panel Bus Bar Rear Side	55.8°C	Hot
APFC Capacitor Terminal-Rear Side	74.5°C	Hot
APFC- Front - Contactor / MCCB	53°C	Slight Hot
APFC- Front - Contactor/MCCB	54.5°C	Slight Hot
Lift Top Area	50.7°C	Slight Hot
Transformer Bushing	50.7°C	Healthy
Transformer Bushing	53.1°C	Healthy
Transformer Oil Conservator	54.1°C	Healthy
